Reinforcement of Secondary Steel Structure during live production

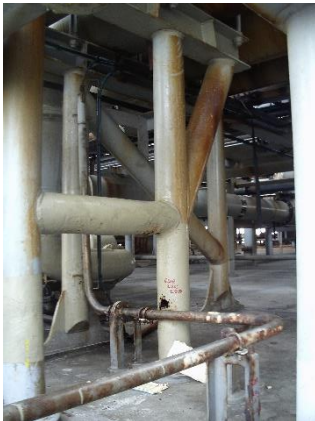
With the ageing of the FPSO fleet, secondary steel structures might be corroded and need to be replaced/reinforced for life extension. Due to busy shutdowns constrained with POB and time, some of those steel structures sitting on top of crude oil tank generate challenges with traditional hot work techniques (HABITAT, SIMOPS, tank cleaning and inerting, loss of production...). Naturally operators have been looking for adapted "cold work" solutions to deal with their maintenance operations during live production.

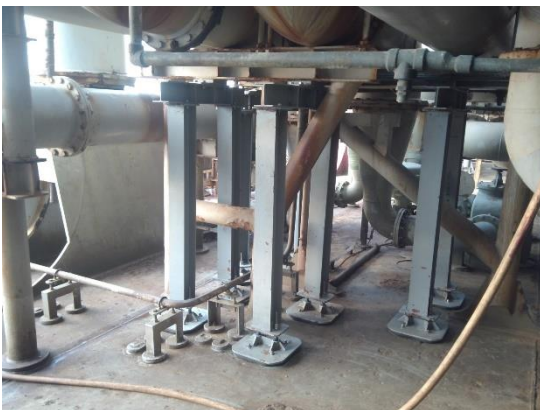
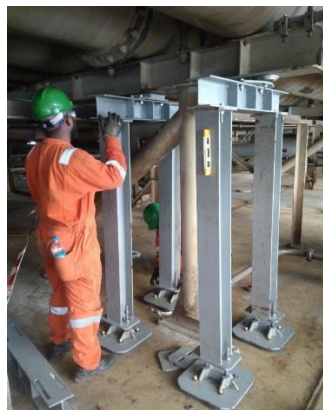
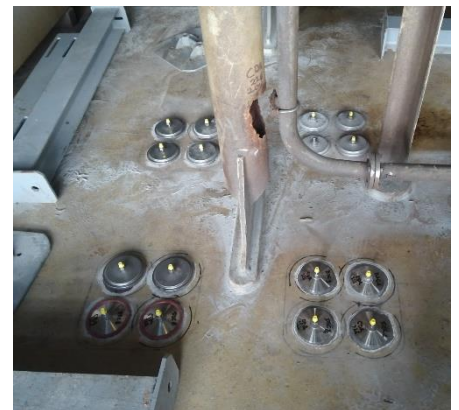
a Nigerian client needed to reinforce a large secondary steel structure (10 large pipe rack support) on top of crude oil tanks. Cold Pad came up with a straightforward and certified fastening solution with no hot works. It relies on the unique features of C-CLAW®, a non-intrusive and heavy-duty fastener.

The Offshore installation was carried out by a 4 people crew during live production . The operations took 12 days and allowed to debottleneck their shutdown operations. It was rated by the onsite construction manager as "*safe, quick and efficient*" allowing to save lots of associated costs and offshore mandays,
